CONTRACT REPORT GL 89.2

# RE-EVALUATION OF THE LOWER SAN FERNANDO DAM

Report 2

EXAMINATION OF THE POST-EARTHQUAKE SLIDE OF FEBRUARY 9, 1971

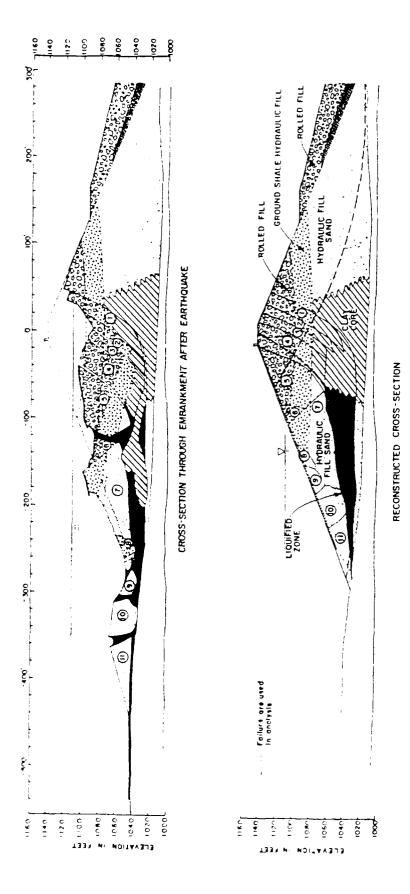
FAILURE AND RECONSTRUCTED CROSS SECTION, LOWER SAN FERNANDO DAM (After Seed et al., 1983) Fig. 1-1

Two cross sections of the Lower San Fernando Dam are presented in Fig. 1-1, one showing the observations made in a trench excavated through the slide area and the other showing a reconstructed cross section of the dam, illustrating the zone in which liquefaction occurred. Large blocks of essentially intact soil from the upstream section of the dam moved into the reservoir, riding over or "floating" on the liquefied soil. After movements stopped, the liquefied soil was found to have extruded out below the toe of the dam and up between the intact blocks, with maximum movements as much as 200 ft (61 m) beyond the toe of the dam. The block of soil which contained the toe of the dam moved about 150 ft (46 m) into the reservoir.

(Seed, 1979). Thus the large slide movements apparently developed in the absence of earthquake-induced stresses and were caused only by the static stresses due to the weight of the materials in the embankment. It can thus be inferred that the earthquake shaking triggered a loss of strength in the soils comprising the embankment and it was this loss of strength, rather than the inertia forces induced by the earthquake shaking, which led to the sliding of the upstream slope.

It has been estimated that the slide movements in the Lower San Fernando Dam developed mainly in about 40 seconds, suggesting that the average rate of movement was about 5 ft/sec or 3 mph (5 kph). This comparatively slow rate of movement indicates that the soil in the slide zone was in a marginal state of limiting equilibrium during the period of sliding and that the factor of safety was only slightly less than 1.0. However the flow of liquefied sand into cracks in the embankment and the flow of sand beyond the toe of the embankment suggests that the strength of the liquefied sand in some zones must have been quite low.

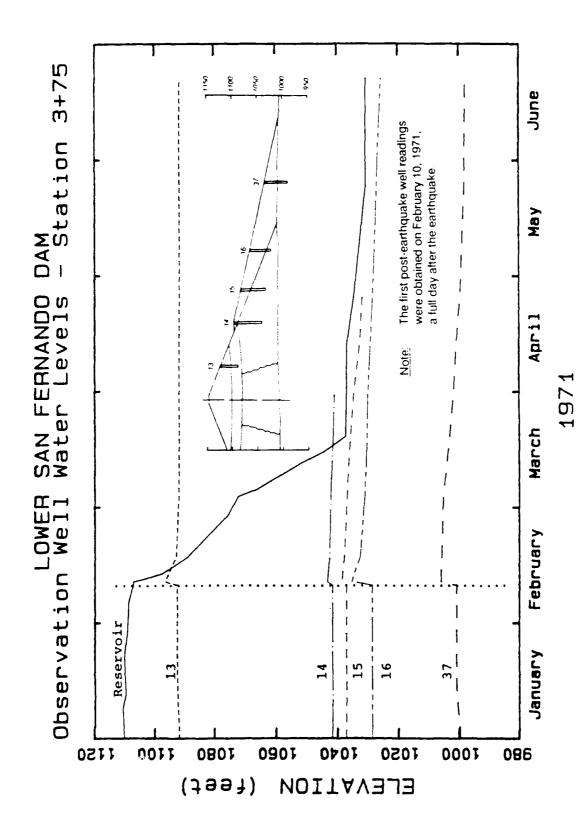
OBSERVED WATER LEVEL CHANGES IN WELLS IN DOWNSTREAM SHELL AND FOUNDATION OF LOWER SAN FERNANDO DAM Fig. 1-2

While it is readily apparent that sliding due to liquefaction occurred in the upstream shell of the embankment, performance data from the files of the City of Los Angeles Department of Water and Power show that the water levels measured in wells installed in the downstream shell showed only small changes in elevation as a result of the earthquake shaking (see Figs. 1-2 and 1-3). Thus it would appear that while the earthquake caused a small increase in pore pressure ratio in the downstream shell and its foundation, there was no significant extent of soil liquefaction in this part of the embankment.

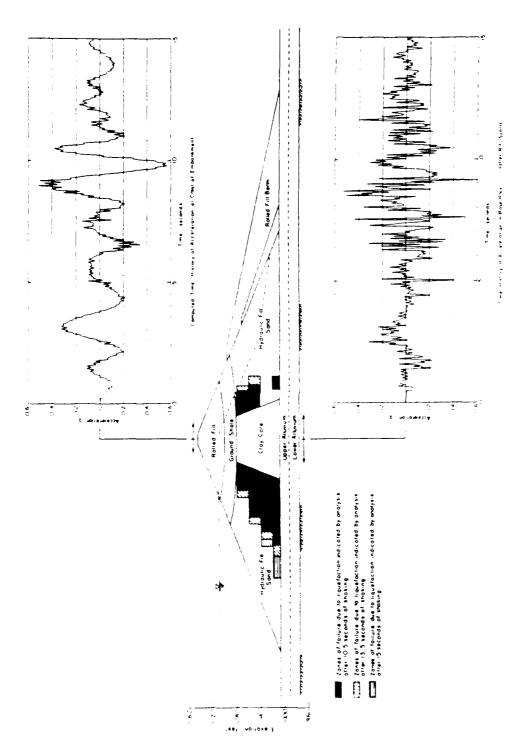
ANALYSIS OF RESPONSE OF LOWER DAM DURING SAN FERNANDO EARTHQUAKE TO BASE MOTIONS DETERMINED FROM SEISMOSCOPE RECORD (After Seed et al., 1973) Fig. 1-4

Application of the method to the Lower San Fernando Dam led to the conclusion that it provided a reasonable basis for evaluating the location and extent of the zone of liquefaction in the upstream shell, as shown in Fig. 1-4. The analysis also indicated that liquefaction would be expected in limited zones of the downstream shell, as shown in Fig. 1-4. When the liquefied soil was considered to have no residual strength the computed factor of safety of the upstream shell was about 0.8 and it was thus concluded that the analysis would indicate that failure would have occurred. However because of the location and limited extent of the zones of liquefaction in the downstream shell there was no danger of sliding in the downstream direction. The same method of analysis also indicated failure of the Sheffield Dam in an earthquake in 1925, and it correctly indicated no failures, and in fact no liquefaction, in typical hydraulic fill dams subjected to earthquake motions from Magnitude 6.5 earthquakes producing a peak acceleration of about 0.2g (Seed et al., 1973). This is in accordance with the observed behavior of a number of such dams including Fairmont, Silver Lake, and Lower Franklin dams in the 1971 San Fernando earthquake. The method also seemed to explain

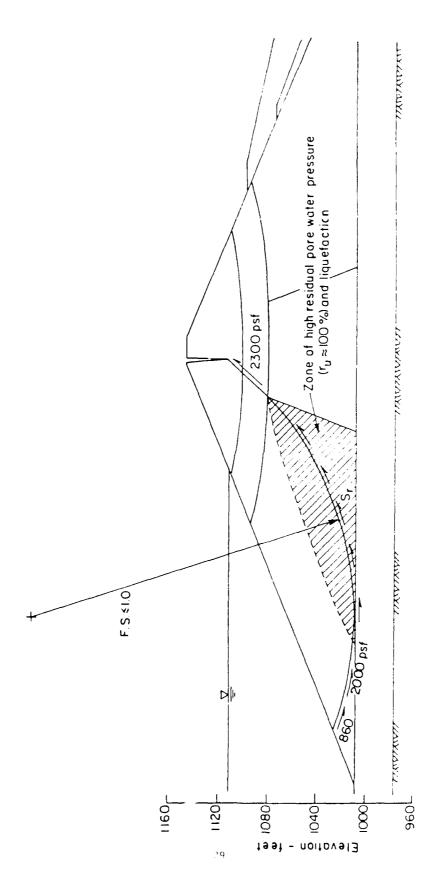
Fig. 1-8 CROSS SECTION OF LOWER SAN FERNANDO DAM AT END OF EARTHQUAKE

In the case of the Lower San Fernando Dam slide, for example, the configuration of the upstream shell of the embankment when sliding was initiated was approximately as shown in Fig. 1-8. Analyses indicate that the average driving stress along the potential failure surface was about 850 psf. If it is assumed that all the soil along the failure surface was liquefied and that the factor of safety at this time was unity, then it would be concluded that the residual or steady-state strength of the liquefied soil was about 850 psf in this case.

If the residual or steady-state strength of the soil were indeed close to 850 psf, however, then only a relatively small movement of the slide mass,

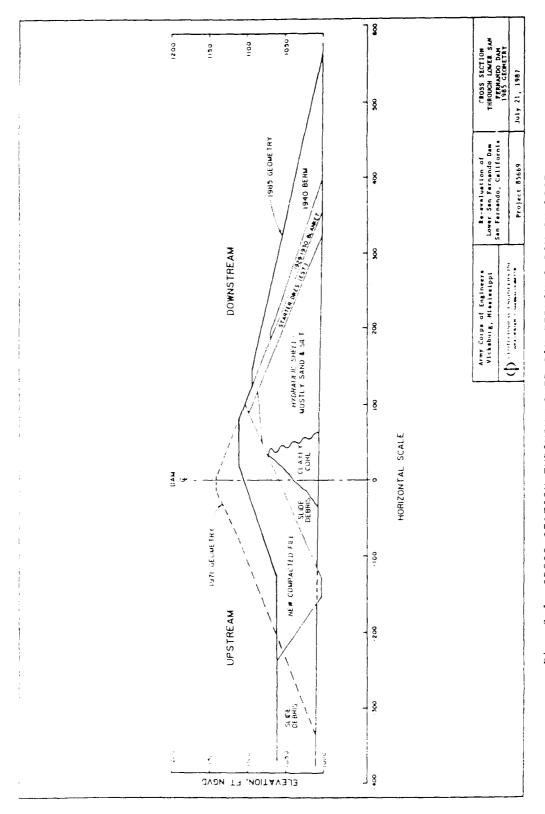
Fig. 2-1 CROSS-SECTION THROUGH LOWER SAN FERNANDO DAM IN 1985 (after GEI)

Since the failure of the upstream slope of the Lower San Fernando Dam in 1971, the dam has been reconstructed to serve as an emergency water retaining structure with the configuration shown in Fig. 2-1. The original upstream shell has been replaced by a compacted fill but the downstream shell below El. 1100 remains essentially as it was at the time of the 1971 earthquake. Since the original hydraulic fill embankment was probably reasonably symmetrical in configuration and properties about the center line of the crest, the properties of the soil forming the upstream shell can be evaluated with a reasonable degree of accuracy on the basis of the properties of the hydraulic fill comprising the present downstream portion of the embankment.

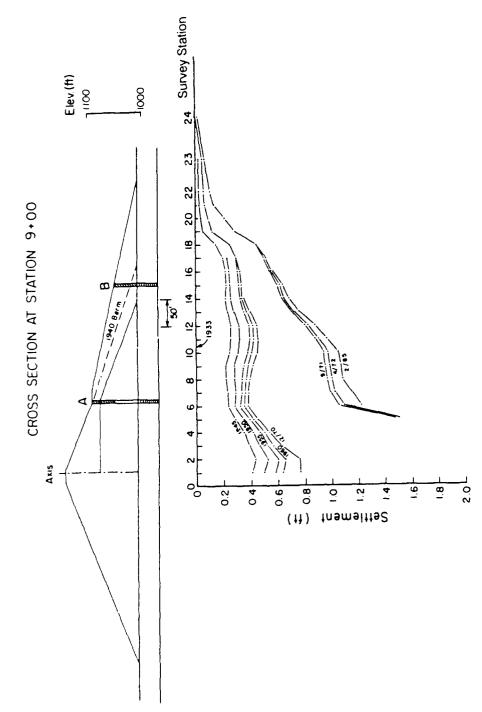
Fig. 3-1 OBSERVED SETTLEMENTS ALONG CROSS-SECTION THROUGH STATION 9+00
(Data provided by Geotechnical Engineers Inc.)

Estimates of the changes in dry density or void ratio of the hydraulic fill since the time of the earthquake can be made from comprehensive settlement observations made on the downstream shell of the dam by the Los Angeles Department of Water and Power both prior to and following the 1971 earthquake. Fig. 3-1, for example, shows settlements measured on the surface of the embankment normal to the axis of the dam at Station 9+00. The test shaft is located 122 ft south of the axis at Station 5+85. For point A, located on the horizontal berm at about the same distance from the axis as the test shaft, it may be seen from Fig. 3-1 that the settlement in the period from December 1970, just before the earthquake, to February 1985, the year the samples were taken from the embankment, was about 0.82 ft. This represents the combined compression of the dense soil above the hydraulic fill, the zone of hydraulic fill above the piezometric surface at the time of the earthquake, the saturated zone of hydraulic fill and the foundation soils. This comprises about 40 ft of compacted soil and partially saturated hydraulic fill above Elevation 1057,

It may also be seen from Fig. 3-1, that significant settlement has occurred on the top of the 1940 rolled fill berm at point B where the height of the layer of hydraulic fill in the underlying soil column is zero. The settlement at point B in the period between the earthquake and sampling in 1985 is about 0.32 ft. This represents the settlement of a 40 ft column of partially saturated denser soils and the underlying 30 ft depth of foundation soil. A comparison between the soil conditions in the columns underlying points A and B, and the settlements of points A and B is shown in Fig. 3-2.

The difference between the observed settlements at points A and B is presumably due to the vertical compression of Zones 2, 3, 4 and 5 of the saturated hydraulic fill in the period Feb. 1971 to October 1985, i.e. about 0.82- $0.32 \approx 0.50$  ft. The total depth of saturated (at the time of the earthquake) hydraulic fill contributing to this settlement is about 50 ft as shown in Fig. 3-2. Zone 5 of the hydraulic fill comprises only about 15 ft of this thickness but it probably contributes disproportionately to the settlement. A conservative estimate would be that Zone 5 contributes about 45% of the total compression although it makes up only about 30% of the thickness.

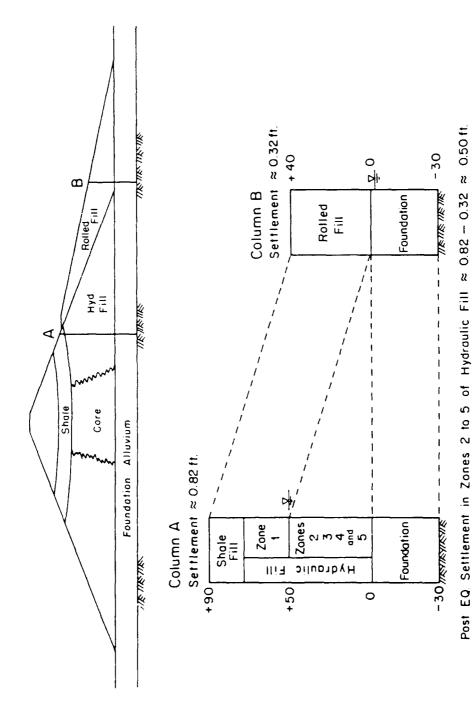
Fig. 3-2 OBSERVED SETTLEMENTS ALONG CROSS-SECTION THROUGH STATION 9+00 (Data provided by Geotechnical Engineers Inc.) CROSS SECTION AT STATION 9+00

about 50 ft of hydraulic fill in Zones 2, 3, 4 and 5, and about 30 ft of foundation soils, as shown in Fig. 3-2.

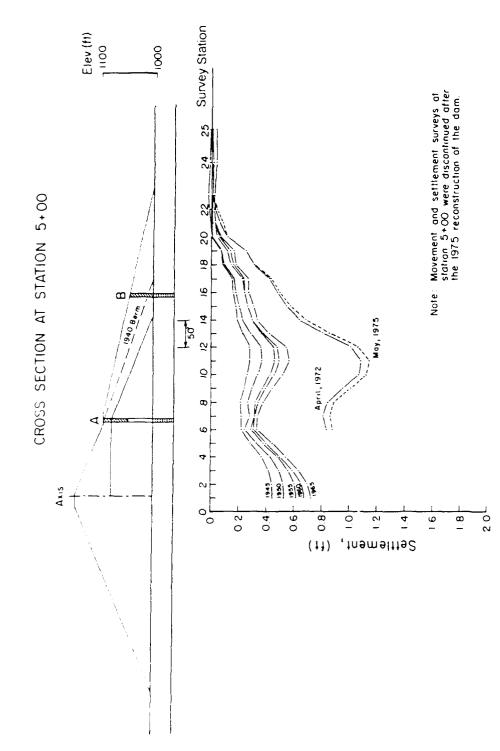
COMPARISON OF POST-EARTHQUAKE SETTLEMENTS FOR COLUMNS A AND B ALONG CROSS-SECTION THROUGH STATION 5+00 Fig. 3-3

Settlement data for the section through the embankment at Station 5+00 on the axis of the dam are shown in Fig. 3-3. Although this data is not so complete as for the section at St. 9+00 (records were discontinued in May, 1975) it never-the-less provides a good basis for evaluating the change in void ratio of the lower part of the hydraulic fill, especially with the data at St. 9+00 to serve as a guide. Thus, following the same procedure as that outlined above, the following results are obtained:

Estimated post-earthquake settlement of point A  $\approx 0.57 \text{ ft}$ Estimated post-earthquake settlement of point B  $\approx 0.26 \text{ ft}$ Estimated change in thickness of Zones 2-5 of hydraulic fill from pre-earthquake condition to time of sampling in 1985  $\approx 0.31 \text{ ft}$ Estimated compressive strain in Zone 5 of hydraulic fill  $\approx \frac{0.45 \times 0.31}{15}$   $\approx 0.9\%$ Estimated change in void ratio of Zone 5 since earthquake  $\approx 0.016$

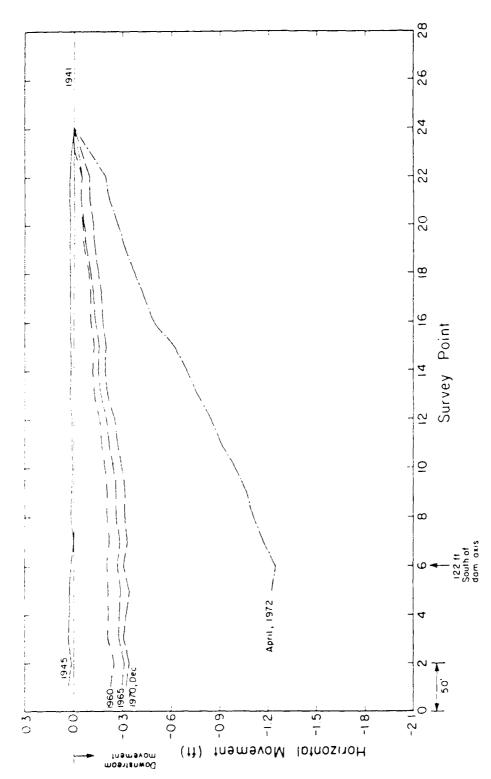
Fig. 3-4 OBSERVED HORIZONTAL MOVEMENTS OF SURVEY POINTS ALONG CROSS-SECTION THROUGH STATION 9 + 00 (Data provided by Geotechnical Engineers Inc.)

In addition to void ratio changes due to vertical compression there may also have been some densification due to lateral compression of the hydraulic fill. Fig. 3-4 shows the lateral movements of survey points along the downstream section of the embankment through Station 9+00 from 1945 to 1972. It is clear that the earthquake caused a marked increase in lateral movements of the survey points. However it is not clear whether these movements were due to lateral compression of the embankment or to shear deformations of the embankment and it seems highly probable that they were due mainly to shear

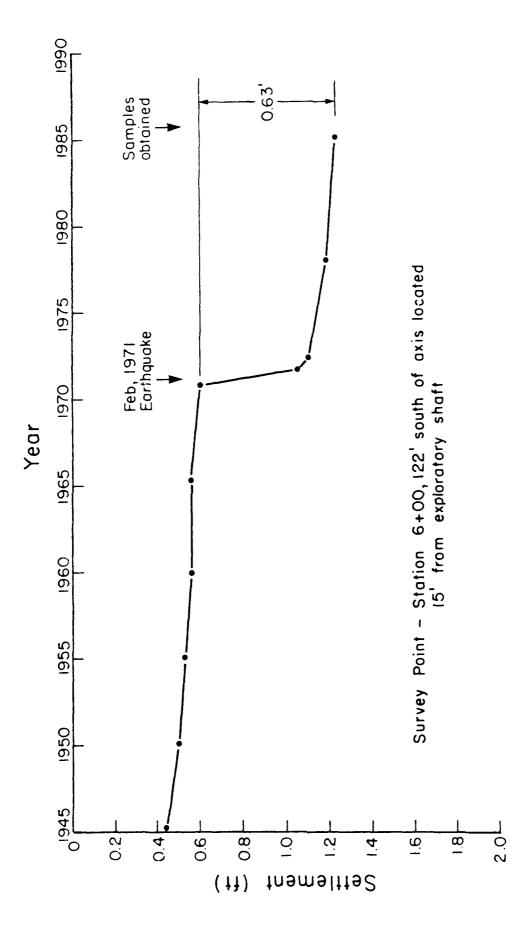
(Data provided by Geotechnical Engineers Inc.) SETTLEMENT RECORDS FOR SURVEY POINT LOCATED 15 FT FROM EXPLORATORY SHAFT Fig. 3-5

Since the samples used in the testing program described in this report were obtained principally from Zones 2 and 5 of the hydraulic fill, it would appear that a representative value for this void ratio change based on these results would be somewhere between 0.011 and 0.023.

Based on the preceding analyses of void ratio changes since the 1971 earthquake, it was considered appropriate in interpreting the test data to allow for an average post-earthquake chaege in void ratio of 0.020 for all samples prior to their extraction from the ground in the 1985 sampling program.

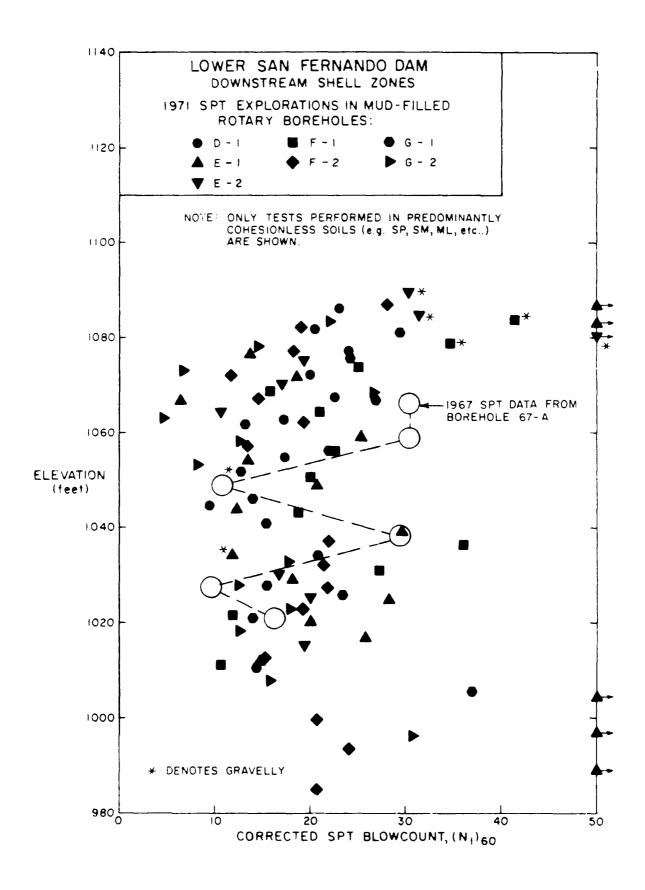
Fig. 4-6 COMPARISON OF SPT DATA IN 1967 AND 1971 INVESTIGATIONS

For comparison purposes, the six SPT N-values measured in the 1967 investigation were converted to  $(N_1)_{60}$  values and these results are superimposed on the results of the 1971 investigation in Fig. 4-6. The 1967 data were believed to be obtained using a conventional Donut Hammer and a rope and pulley test procedure. Consequently the energy ratio used in this test was considered to be about 50% and the field data were corrected accordingly. The data were also corrected for the presumed absence of liners in the sampling tubes. In addition, because the N-values measured in the 1967 investigation were counted for 0 to 12 inches of penetration rather than the 6 to 18 inches range required in the standard procedure, the values were increased by 15% to allow for this deviation from standard practice. This correction was proposed by Schmertmann (1979). The results are shown in Fig. 4-6. It may be seen that they reflect near upper and lower bounds for the 1971 data.

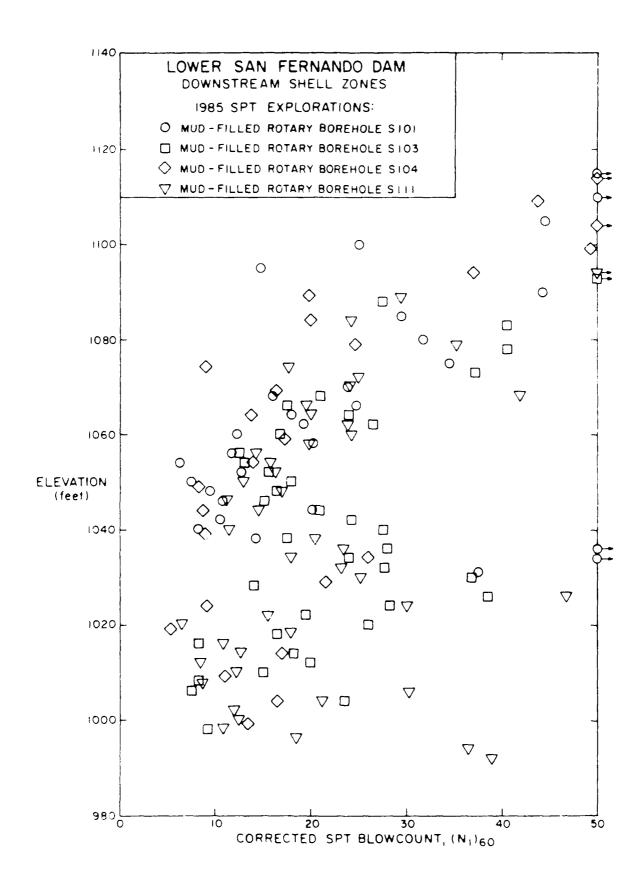
Fig. 4-7 RESULTS OF STANDARD PENETRATION TESTS IN DOWNSTREAM SHELL IN 1985 INVESTIGATION

Values of  $(N_1)_{60}$  determined in the 1985 investigation based on measurements made in Borings Nos. S101, S103, S104 and S111 in the downstream shell are shown in Fig. 4-7. As before, measured values were corrected for energy ratio effects (the energy ratio for the hammer used in the 1985 program was measured to be 72%) and for the absence of liners in the sampling tube, and then normalized to an overburden pressure of 1 tsf using the value of  $C_N$  shown in Fig. 4-3.

The resulting values of  $(N_1)_{60}$  are shown in Fig. 4-7, and the results of statistical analyses of the values in the same four layers as those shown in Fig. 4-5, are presented in Fig. 4-8. The presence of a more resistant layer

of fill between approximately Elevations 1024 and 1038 is readily observable in these data also.

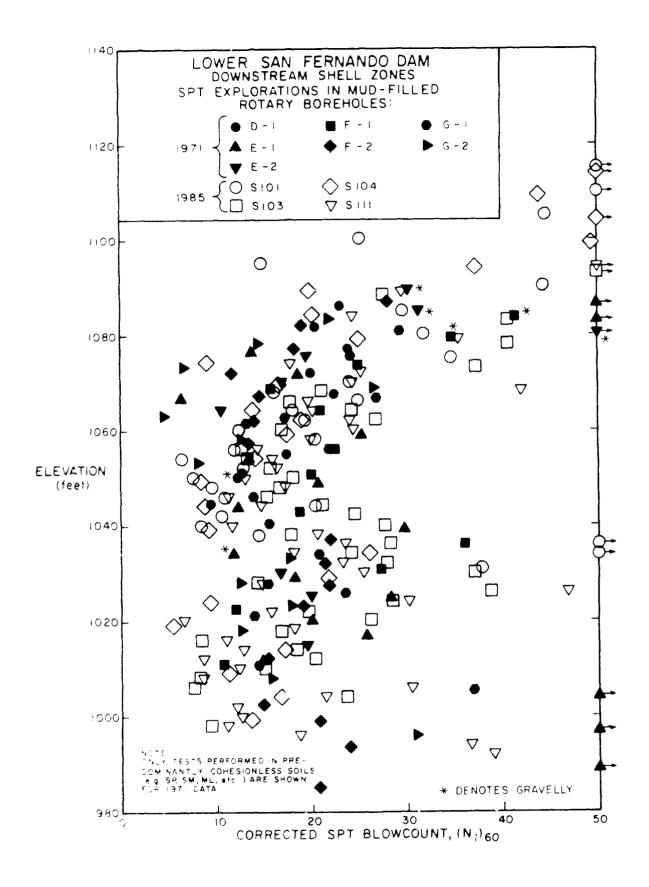
Fig. 4-9 COMPARISON OF RESULTS OF SPT DETERMINATIONS IN DOWNSTPEAM SHELL IN 1971 AND 1985 INVESTIGATIONS

For comparison purposes, the values of  $(N_1)_{60}$  measured in cohesionless soil in the downstream shell in the 1985 investigation are compared with values determined in the 1971 investigation in Fig. 4-9. The general distribution seems to be about the same for both studies.

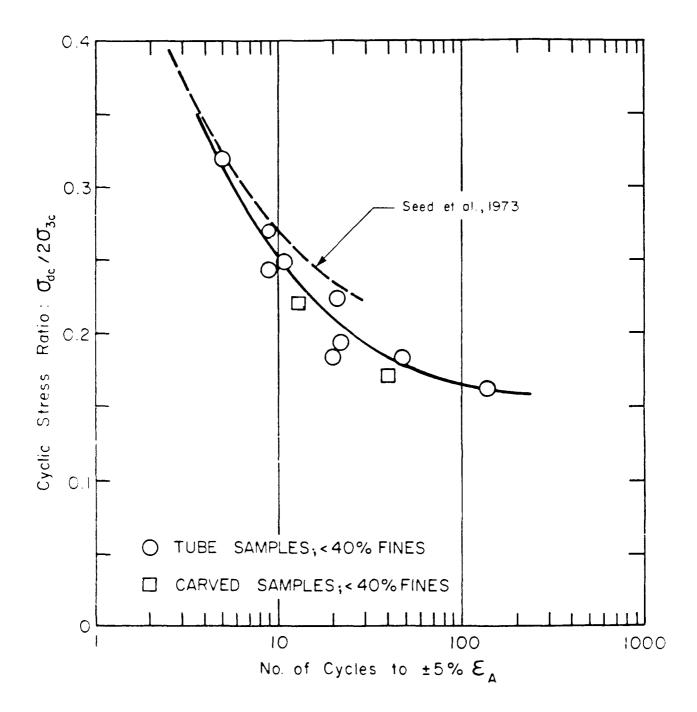
Fig. 5-1 RESULTS OF CYCLIC LOAD TESTS ON UNDISTURBED SAMPLES OF SILTY SAND

The results of these tests are also shown in Fig. 5-1. It was found that for samples which developed a condition of  $r_{\rm u}\approx 100\%$  and cyclic strains

of ±5% strain in low numbers of cycles (say less than 10), the cyclic stress ratios were very similar to those determined in the 1971 investigation. However for samples reaching the prescribed failure condition in larger numbers of cycles, say 15 to 40 cycles, the cyclic loading resistance was 10 to 15 percent lower than that determined in the 1971 investigation. No reason for this small difference in behavior could be determined. There appeared to be no significant difference between the results of tests on samples obtained from borings or from the test shaft. The range of grain size distribution curves for the samples for which data is shown in Fig. 5-1 is presented in Fig. 5-2.

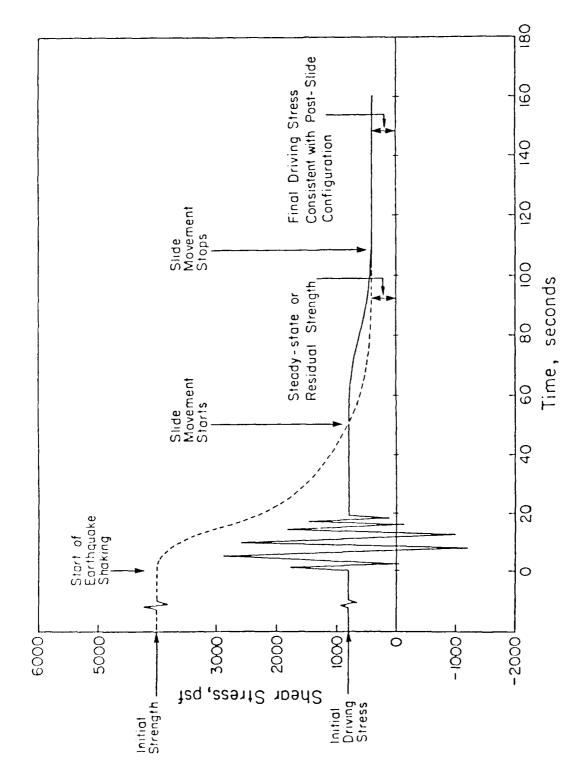
ESTIMATED CHANGES IN AVERAGE DRIVING STRESS AND SHEAR RESISTANCE OF HYDRAULIC FILL NEAR BASE OF UPSTREAM SHELL AFTER START OF EARTHQUAKE UNTIL END OF SLIDE MOVEMENTS Fig. 8-1

2. Also of importance, however, is the fact that even with conservative data interpretation, the steady-state strength determined from the laboratory tests does not indicate the best estimates of the actual residual strength apparently achieved by the liquefied soil (about 300 to 500 psf) in the Lower San Fernando Dam. Based on the results presented in Section 1, the best-estimates of the average pre-earthquake, post-earthquake and post-slide stresses and strengths in the hydraulic sand fill near the base of the upstream shell, and their variations with time after the start of earthquake shaking to the end of sliding, are shown in Fig. 8-1. As the slide movements progressed, the average driving stress was gradually reduced and, since inertia effects were small, sliding would stop when the average
